Exploring the Safety Concerns of the V-22 Osprey

Isabel Mancini¹ and Emily Marshall²

Florida Institute of Technology, Melbourne, FL, 32901, USA

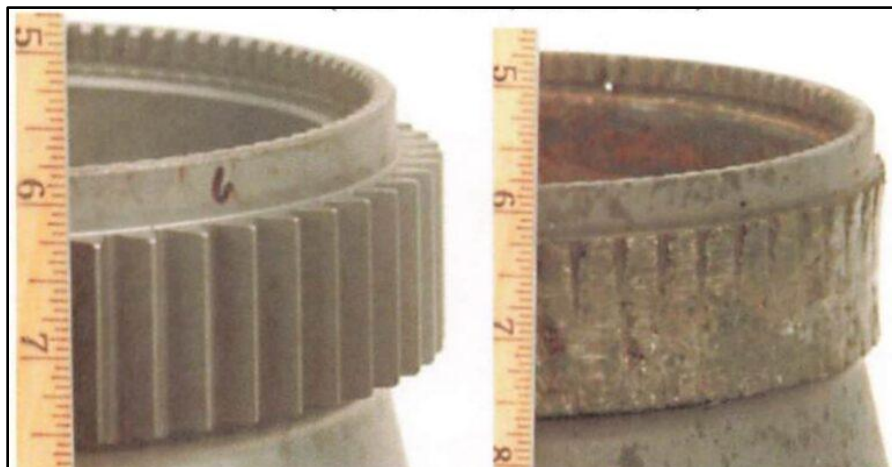
Gearbox malfunctions are a big issue that causes Ospreys to malfunction. The proprotor gearbox allows the vehicle to take off and land vertically but fly horizontally. There are two gearboxes on a V-22 Osprey, one on each side controlling the nacelles. Often, the gearboxes fail due to a cracked gear or excessive wear. This leads to loss of control of the vehicle, causing accidents. On November 29, 2023, about a half mile off the shore of Yakushima Island, Japan, a US Air Force CV-22B Osprey crashed, killing all eight crew members on board. According to an Air Force investigation, Tara Copp from Associated Press News reported the accident “was caused by cracks in a metal gear” [3] that began to shred, sending debris throughout the gearbox. This caused it to fail and the proprotor to stop operating. This scenario is “similar to those seen on seven previous failures in low-speed planetary pinion gears” [4].

One cause of the gears in the gearboxes breaking is that Universal Stainless was found to have a defect “non-metallic inclusions” [6] in the metal alloy used to manufacture the gears. The non-metallic alloy found in these defects hinders the durability of the gearboxes, which results in the cracks and chips causing the failures. (Fig 3.) According to reports, “given the rate at which those inclusions were making it into the alloy used in the gears, a failure such as the one Gundam 22 experienced was bound to happen.” [4] Gearboxes are the only mechanism attaching the nacelles to the body of the V-22 Osprey, resulting in stress added on them. Not only do they have the weight of the nacelles, but they also have the engine and added vibrations. The gears themselves are made from an X-53 steel alloy, which is known for its high strength and toughness against fracture resistance, which is why it is a great material for the gears in the gearbox, considering the high stress they are under. The defect in the metal alloy hinders the strength of the X-53 steel alloy, relating back to Osprey crashes dating back to 2013. The defect in the alloy weakens the strength, which is why the gearboxes result in more failures.

Fig 3. Gears Worn Down from CV-22 Osprey [7]

The military is also working towards improving the quality of the steel used in the gearboxes to prevent any chips in the gears resulting in gearbox failures. They plan on using a “more refined Triple-Melt steel” [11] in the gearboxes, hopefully, to minimize chipping during flight. In response to the hard clutch engagements, a new input quill assembly is being designed to reduce or eliminate the hard clutch engagements, while pilots of the current input quill assembly were warned about this potential hazard. [11] The Naval Air Systems Command also inspected the flight hours on each input quill assembly, determining if the Osprey was safe to fly. Following the crash in June 2022, the Marine Corps put a flight data recorder designed to survive crashes to monitor flight data and pinpoint the failures.

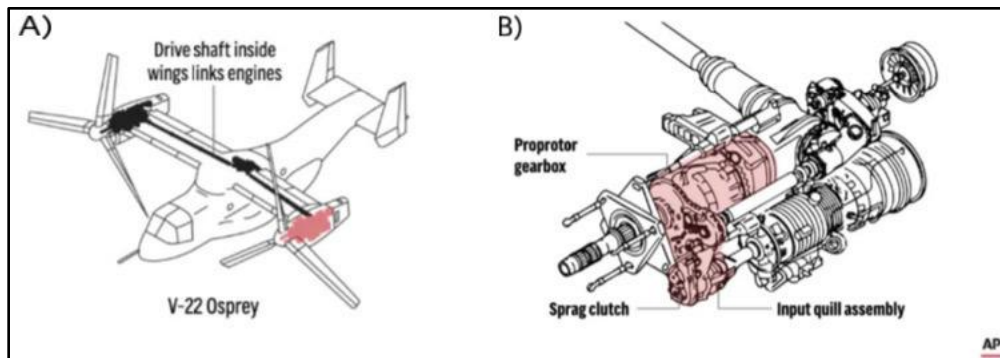
The input quill assembly houses the clutch inside the proprotor gearbox, which transmits power from the engines to the nacelles. (Figure 4A) The input quill rotates the nacelles by engaging and disengaging the clutch smoothly, allowing for a safe transition. (Figure 4B) However, faulty input quill assemblies have been linked to crashes, the most recent in June 2022. When an input quill fails, it is known as a hard clutch engagement (HCE); the HCE, which caused the June 2022 crash, had restricted power from the right motor, causing it to lose power. The Marine Corps released a statement saying, “The dual HCE event and subsequent single engine/ICDS failure created an unrecoverable departure from controlled flight.” [8]

This slip results in all the power being directed into one engine, causing the other to fail. The system of the input quill assembly uses sprag clutches limiting rotation to only one direction. The sprag clutches allow one component to rotate freely while applying force to the other component, preventing it from rotating in the opposite direction. When force is applied, all the sprags should catch; however, when the sprags do not catch all at once, the clutch slips, leading to the hard clutch engagement, restricting power, and causing the nacelle failure. Rather than gathering a full understanding of why this happened, a solution was implemented to replace the input quill assembly after a certain number of hours. Office officials claimed this solution “would prevent 99% of future hard clutch engagements.” [4] Families of the victims of the June 2022 crash were dissatisfied with this solution, claiming the issue was with the system itself and sued for wrongful death. There have been 19 hard clutch engagement incidents that have been recorded throughout the Ospreys’ time in operation. During a meeting in the Congressional office, officials pointed out that there have been no hard clutch engagement occurrences since the new solution was put forth. [4] Ospreys have been grounded twice since the June 2022 incident for hard clutch engagement issues.

Fig 4. (A) Diagram of Proprotor Gearbox Location & (B) Components [3]
