# The Use of Boron Potassium Nitrate (BKNO<sub>3</sub>) in Recovery Deployment Systems for High Altitude Sounding Rockets

Michael Peña\*, Virginia Anne E. Tennant<sup>†</sup>, and Morgan C. Gregg<sup>‡</sup>  
*Georgia Institute of Technology, Atlanta, GA, 30332*

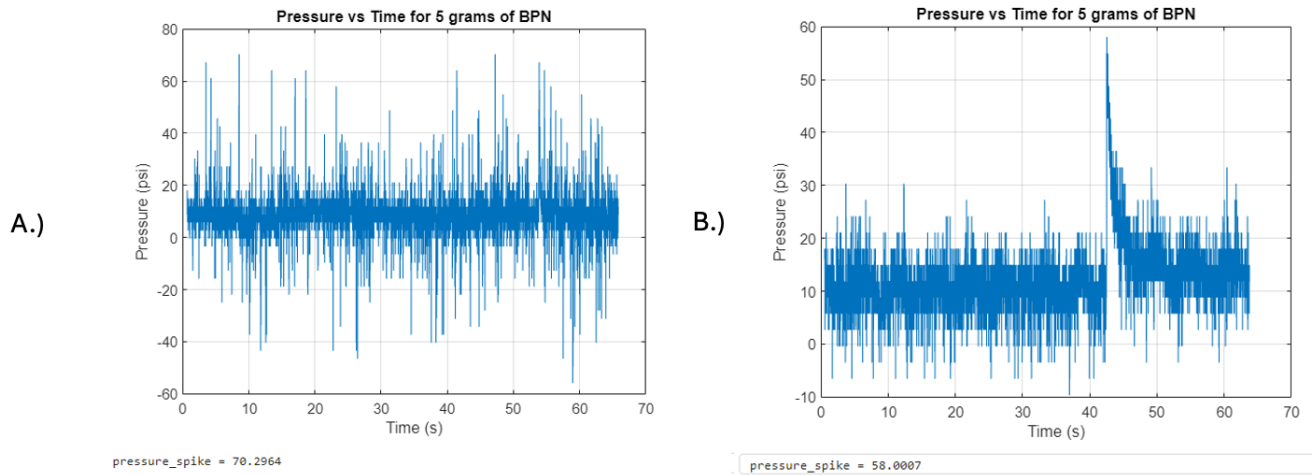
**Fig. 1 A.) Initial 5 gram test data, improper seal caused by faulty lid.  
B.) 5 grams test data with new lid**

Eight tests were conducted with varying amounts of BPN. The results are as follows. The first test contained 5 grams of BPN which ignited however an improper seal in both the forward and aft ends of the chamber allowed for gas to escape, this led to noise polluted data where a pressure spike was not very noticeable as shown in Figure One. The second test attempted to collect data with 5 grams of BPN, but structural weakness in the lid led to permanent damage of the threads for the pressure transducer and thus testing had to be halted until a new lid could be manufactured. The third and final test again ran five grams and the data collected indicated a good seal which is represented in Figure One. This was the first successful absolute pressure reading during the testing process. Despite the low quantity of BPN, the combustion byproducts could still cause issues. Most notably after successive ignitions, the plastic wire terminals mounted to the lid began to melt, making the screw heads inaccessible, as shown in Figure Two. These had to be replaced before further testing could continue.

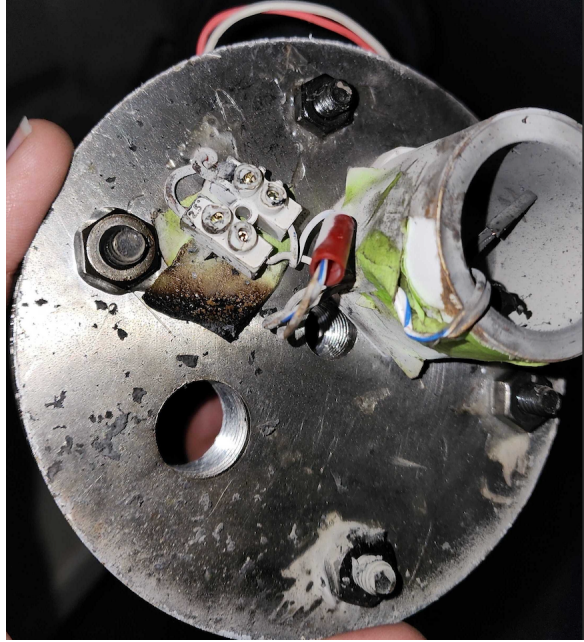
**Fig. 2 Melted wire terminals after 5 gram test**

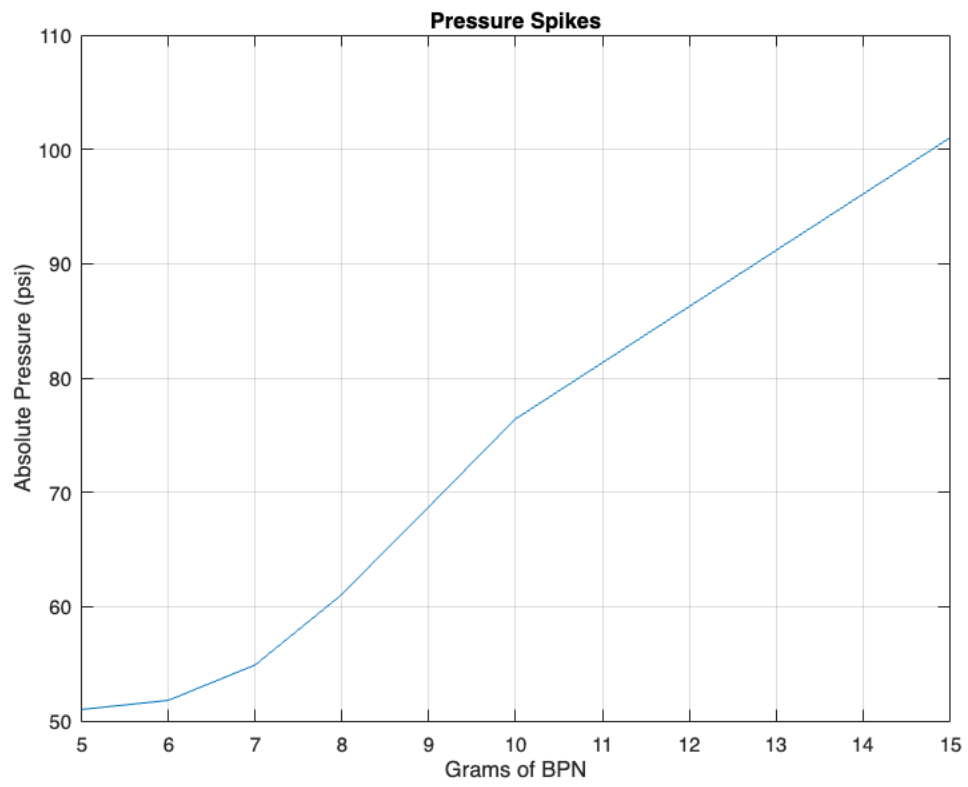
**Fig. 4** Pressure spikes at each weight of BPN

By plotting each pressure spike over grams, we can see a linear trend for pressure, resulting in a predictable psi for certain quantities of BPN.

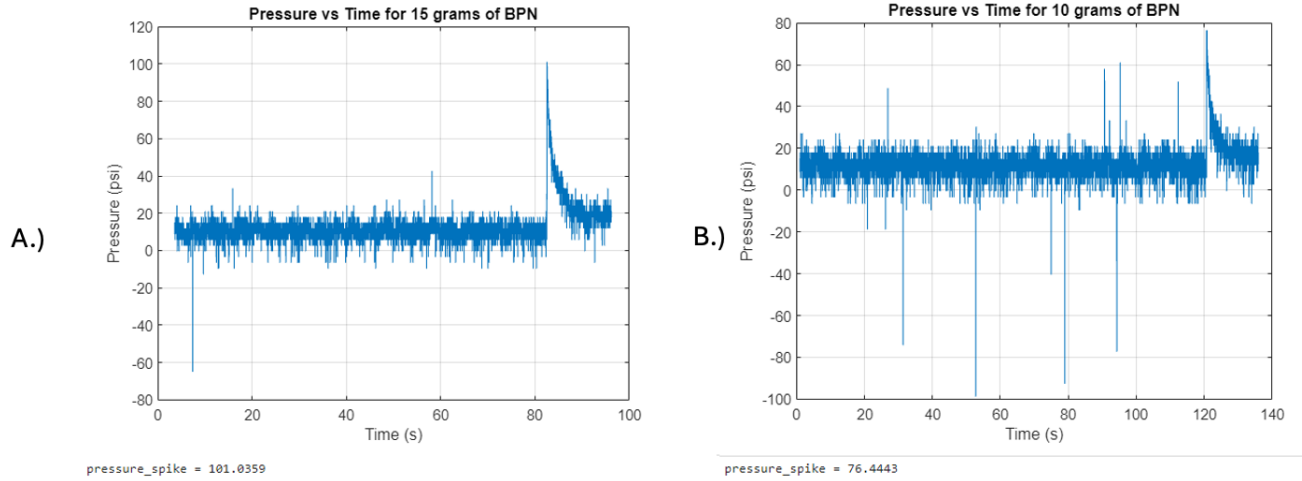
**Fig. 5**  
**A.) 10 grams of BPN Test Data**  
**B.) 15 grams of BPN Test Data**

The final round of testing consisted of a 10 gram and 15 gram test of BPN. The 10 gram test was loaded in and ignited, its data is shown in figure four. After the 10 gram test, the wire terminals, which were attached via epoxy to the lid, snapped off and the plastic body of the wire terminal began to melt from the heat. The soot from the BPN had also caked onto the lid and side walls of the chamber, becoming hazardous to handle without proper PPE. Another observation was the formation of a brown-orange haze wherever the PVC chargewell had direct contact with the exhaust gasses after ignition. After this initial test, the lid was thoroughly cleaned and re-assembled in preparation for the 15 gram BPN test. Once the 15 gram test was loaded, it was ignited and the following was observed. Every surface had been completely caked in soot, the wire terminals, wires and PVC were completely scorched and would require replacement before further testing could commence. There was less ash produced by the cellulose insulation. As shown in figure five, the lid could not be reused with out extensive cleaning and repair.

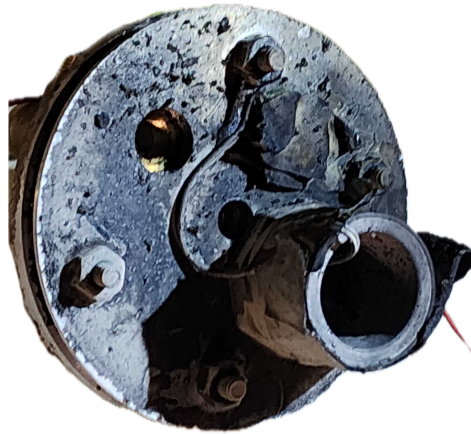
**Fig. 6** Aftermath of 15 gram ignition

A second issue with the use of BPN in these systems is the temperature of the air once BPN is combusted. This concern was founded from observations made after testing and during lid cleaning. At and around six to eight grams, the temperature of the air was seen to be only enough to slightly melt and deform the plastic of the wire terminals. The main issues arise from BPN quantities above nine grams. During the testing of this quantity an orange-brown residue was observed on the PVC. At temperatures of 220 Celsius the PVC of the chargewell will begin to decompose and release Hydrochloric (HCl) gas [3], which causes the residue observed. This can prove to be hazardous in settings where these chargewells are not single use. Advanced respirators are needed to be able to filter HCl and can cause severe irritation in the lungs if inhaled. At the same temperatures that PVC begins to decompose and release HCl, most commercial nylon shock cord reach their melting point which can cause fires to spread from the shock cord to the parachute, compromising the recovery system.
