Erosion And Deposition Comparison Of Biochar, Pumice, And Arizona Test Dust On Titanium Coupons

Virginia Tech, Blacksburg, VA 24060, United States

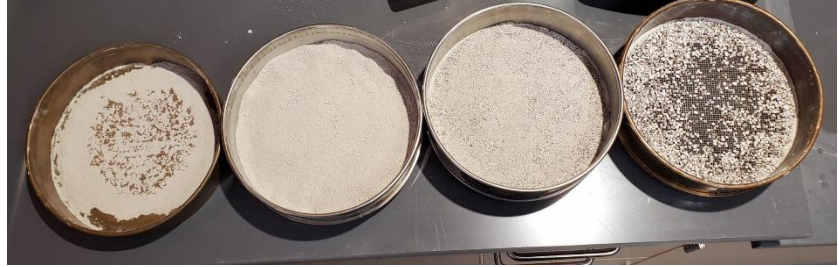
Figure 1. Pumice after shaking sieve

The pumice and biochar were milled using a long roll jar mill from US stoneware (model 801CVM, serial number CM06001). The ATD was not milled as it already met the desired size range. The jar mill has 36 inch long rollers and runs from a 5 horsepower motor [8]. The particulate matter was put into the jar with various sized ceramic balls to grind the particulate down to the desired size. The jar was placed on the rollers then allowed to roll for approximately 1 hour and 30 minutes. After the particulate was milled, it was put through a W.S. Tyler Ro-Tap Model E Test Sieve Shaker to filter the particulate to the desired size range of 50 microns with a maximum of 150 microns. The shaker consisted of 3 filters, from the Fisher Scientific Company, with openings of 1.70 mm, 150 microns, and 45 microns, stacked in that order. The particulate caught by the 45 micron sieve was used for the experiment. The particulate filtered in the sieve can be seen in Figure 1.

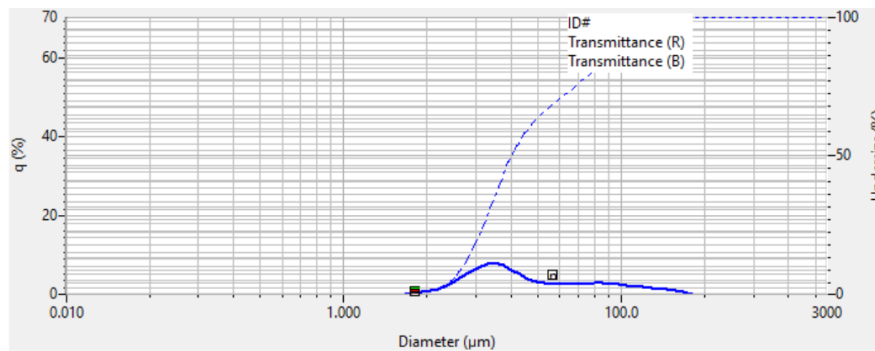
Figure 2. Biochar particle size distribution

As seen in the size distributions above, the particle refinement process worked well to achieve the desired particulate size. The particle size distributions are similar for each particulate which allows for better comparison. The mean sizes of the particulate are seen in **Error! Reference source not found.** While all the particulate mean sizes were below 50 microns, the desired size, this size is ideal as it lowers the chances of the particulate clogging the injector system.

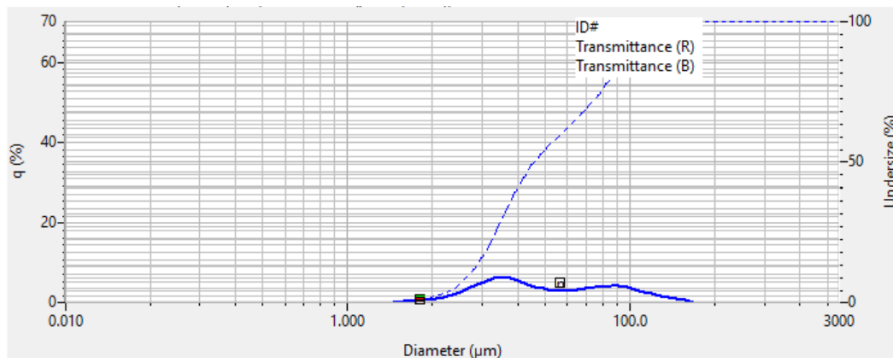
Figure 3. Pumice particle size distribution

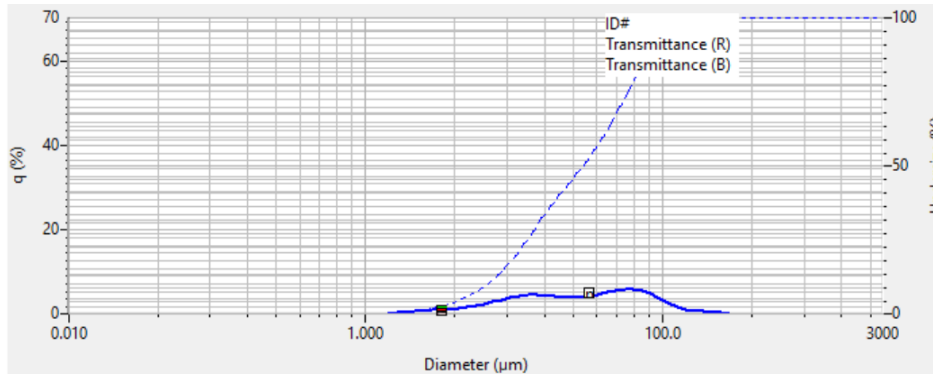
Figure 4. Arizona Test Dust particle size distribution

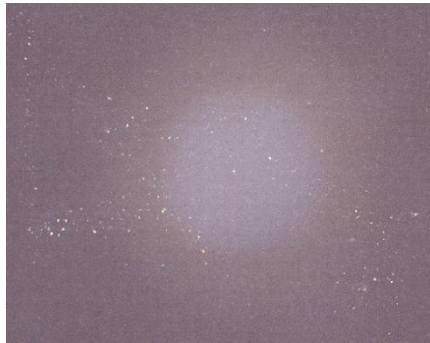
Figure 10. Optical view of coupon exposed to ATD at 2.5x

Figure 10 shows the optical view of a coupon exposed to ATD under 2.5x magnification, and Figure 11 shows the 3D view of the same coupon under the same magnification.

While the coupon appears smoother in the optical image (Fig. 10), the scratches that covered the coupons initially have been eroded away by the ATD. The surface of the coupon is rough and shows signs of pitting in some spots as can be seen by the 3D scan. These results are consistent with the preliminary testing carried out in 2023, and other sand ingestion experimentation. These images also confirm the results from the surface roughness tests. Furthermore, there were also a few spots of deposition found where a grain of ATD stuck to the coupon. However, deposits left by the Arizona Test Dust were not common as only a few particulates stuck to the coupon were found. Erosion was found to be the larger result as seen by the pitting, erosion of the scratches, and the rough surface. These results

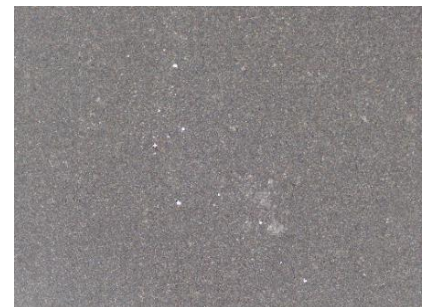
Figure 12. Optical view of coupon exposed to pumice at 5x magnification

Similar to the results from the ATD coupons, the coupons exposed to pumice showed no signs of the initial scratches. This indicates that the pumice was eroding the surface of the coupon, despite the smooth looking surface in the optical view. However, in comparison to the ATD, the surface of the coupon exposed to pumice was not as rough. Little to no deposition was found from the visual inspection that was conducted. These results suggest that in the colder sections of the engine, such as the compressor, volcanic ash will not cause serious deposition, but it has the potential to erode the compressor blades. Literature suggests that particulates ingested by an engine can first smooth compressor blades and lead to greater efficiency, but

Figure 12 is an optical view of a coupon exposed to pumice under 5x magnification, and Figure 13 is a 3D view of the same coupon at the same magnification.
